COMMERCIAL WINDSTORM MITIGATION REPORT (OIR-B1-1802)

Sunshine Terrace Condominium

1241 S. Martin Luther King Jr. Ave., Building B

As of 3/1/2021

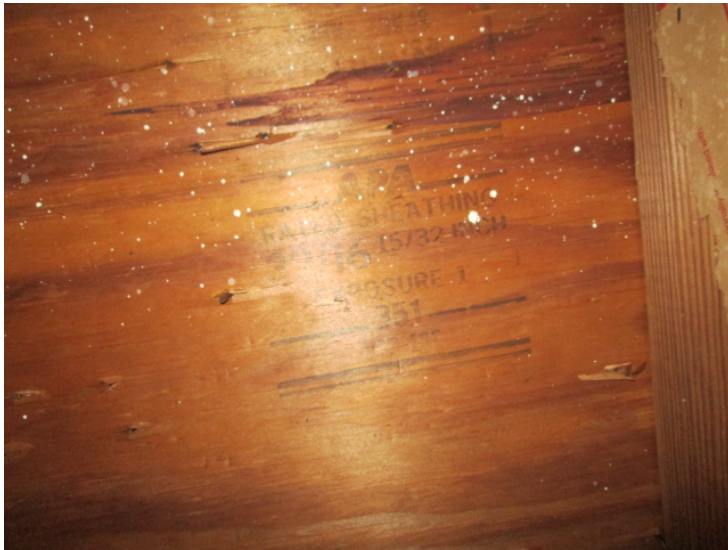
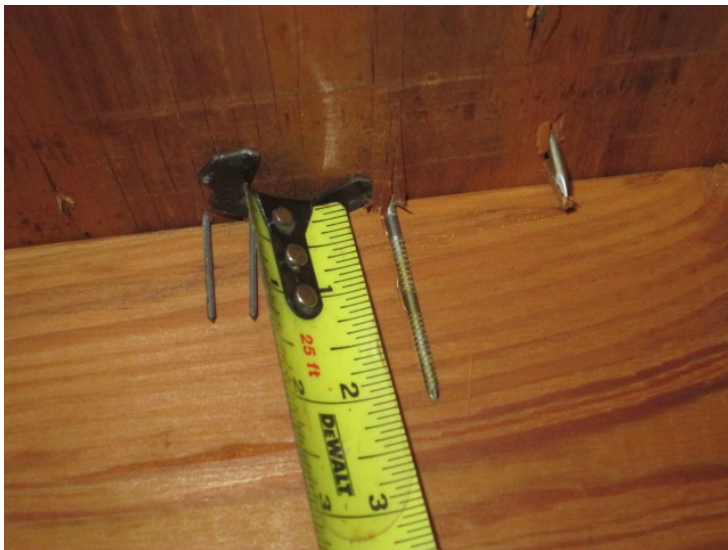
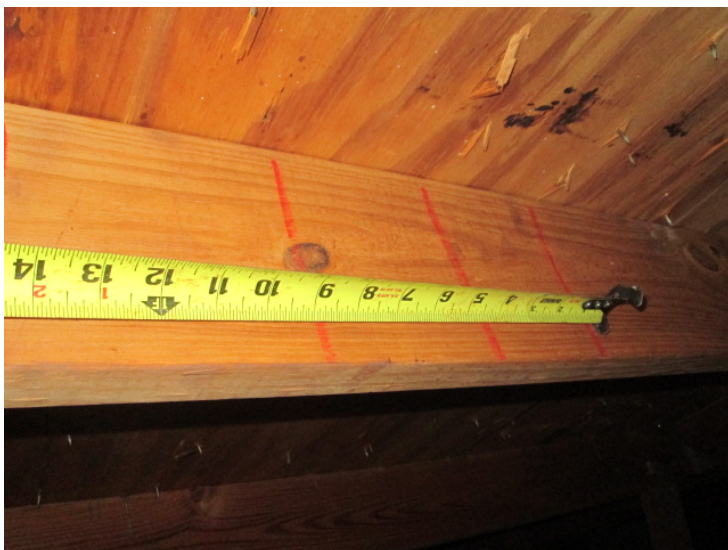
Roof Construction

- 3. Roof Deck Attachment:** **Level C**
Comments: Inspection verified 1/2" plywood roof deck attached with 8d nails at a minimum 6" on the edge & 6" in the field.

- 4. Roof to Wall Attachment:** **Clips**
Comments: Inspection verified hurricane clips fastened with a minimum of three nails.
- 5. Roof Geometry:** **Hip Roof**
Comments: Inspection verified a hip roof shape.

- 6. SWR:** **Yes**
Comments: SWR was verified at time of inspection. The Secondary Water Resistance verified is a self-adhering peel and stick.
- 7. Opening Protection:** **None or Some Glazed Openings**
Comments: No opening protection verified at the time of inspection.
