## COMMERCIAL WINDSTORM MITIGATION REPORT (OIR-B1-1802)

Sunshine Terrace Condominium

1245 S. Martin Luther King Jr. Ave., Building C

As of 3/1/2021

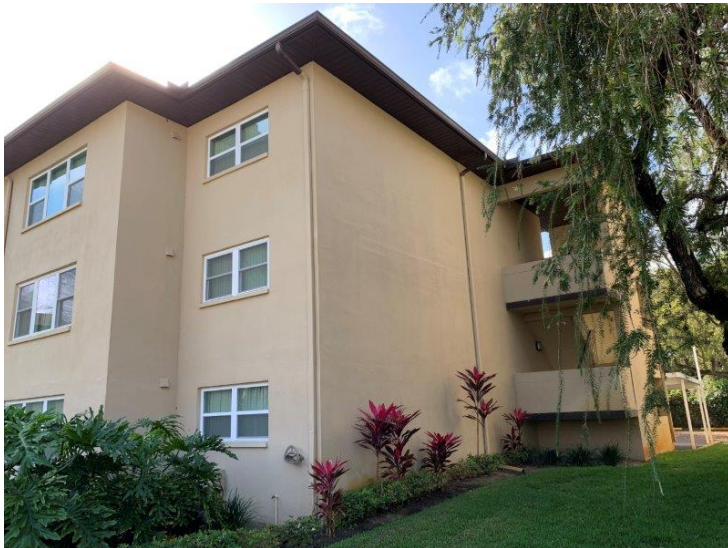
Exterior Elevation

5. **Roof Geometry:**                      **Hip Roof**  
Comments:                                      Inspection verified a hip roof shape.
6. **SWR:**                                      **Yes**  
Comments:                                      SWR was verified at time of inspection. The Secondary Water Resistance verified is a self-adhering peel and stick.

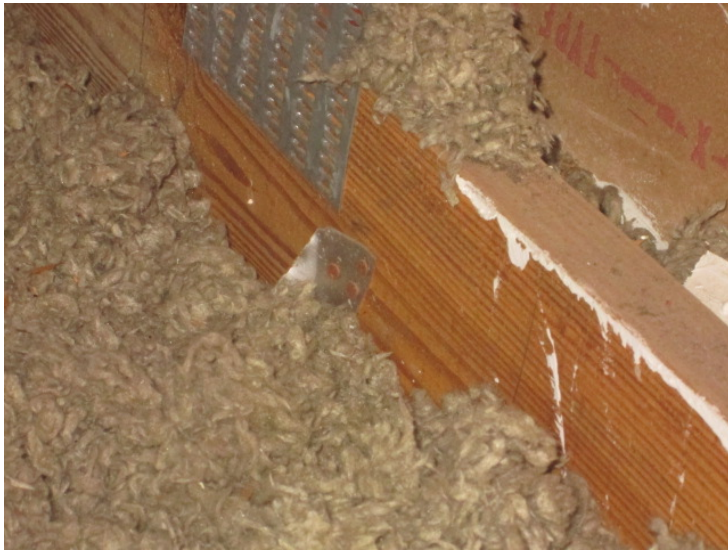
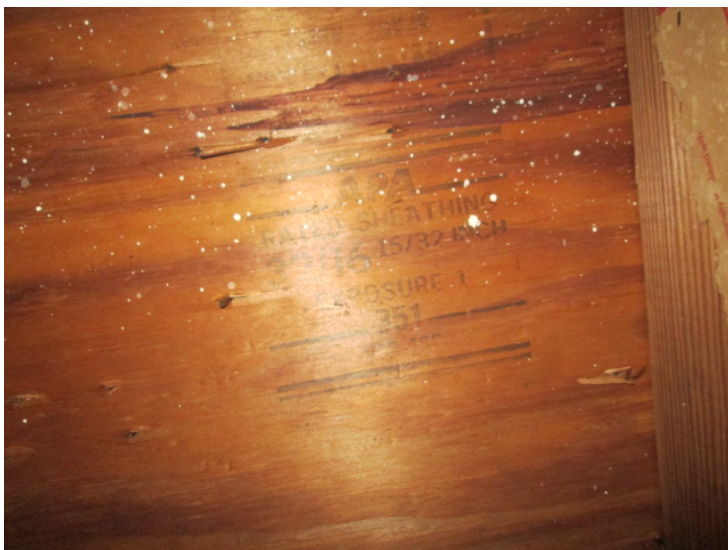
Roof Construction

3. **Roof Deck Attachment:**        **Level C**  
Comments:                                      Inspection verified 1/2" plywood roof deck attached with 8d nails at a minimum 6" on the edge & 6" in the field.

4. **Roof to Wall Attachment:**        **Clips**  
Comments:                                      Inspection verified hurricane clips fastened with a minimum of three nails.
