## COMMERCIAL WINDSTORM MITIGATION REPORT (OIR-B1-1802)

Sunshine Terrace Condominium

1247 S. Martin Luther King Jr. Ave., Building D

As of 3/1/2021

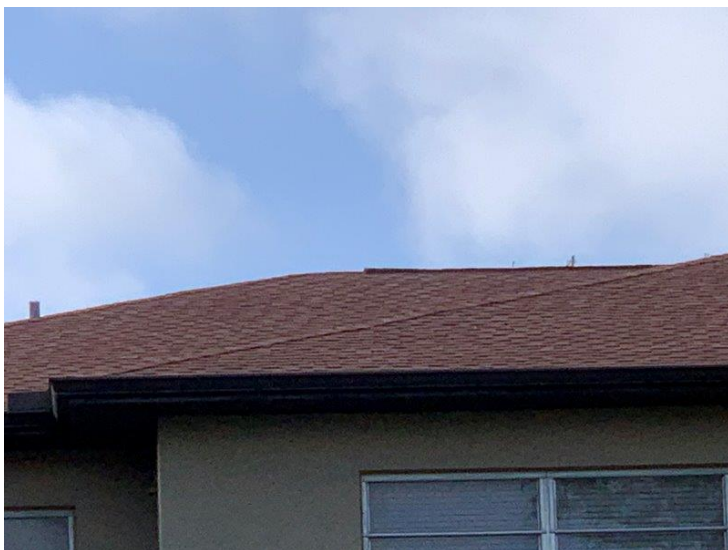
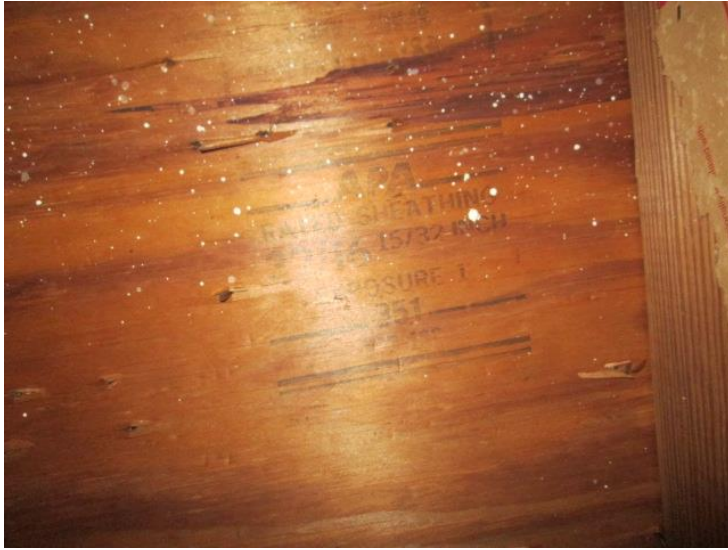
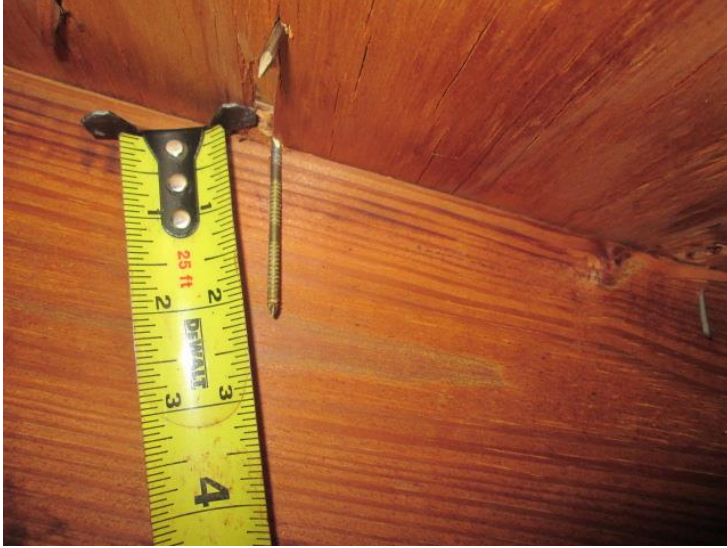
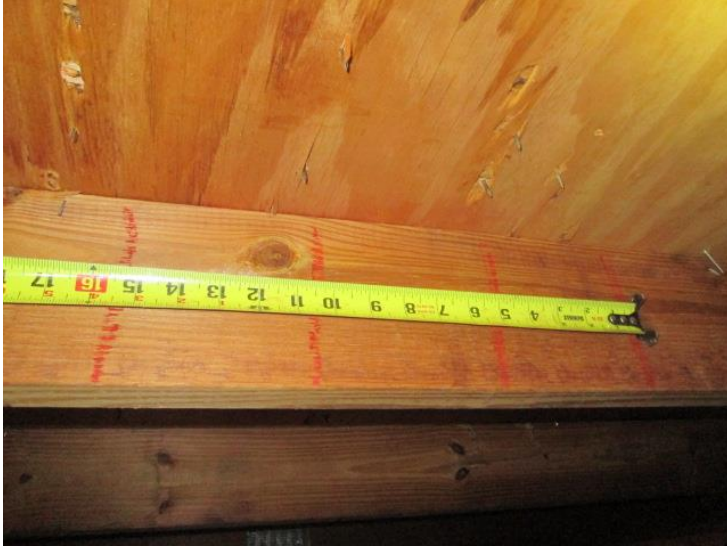
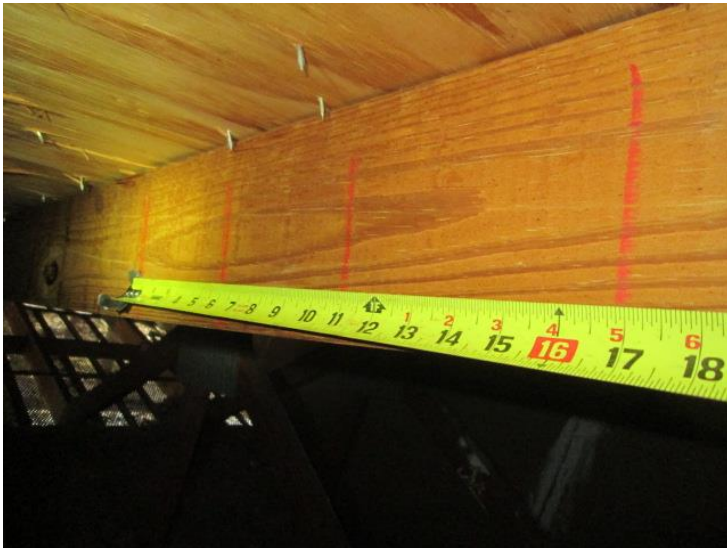
Roof Construction

3. **Roof Deck Attachment:**        **Level C**  
Comments:                                      Inspection verified 1/2" plywood roof deck attached with 8d nails at a minimum 6" on the edge & 6" in the field.

4. **Roof to Wall Attachment:**        **Clips**  
Comments:                                      Inspection verified hurricane clips fastened with a minimum of three nails.

5. **Roof Geometry:**                      **Hip Roof**  
Comments:                                      Inspection verified a hip roof shape.
6. **SWR:**                                      **Yes**  
Comments:                                      SWR was verified at time of inspection. The Secondary Water Resistance verified is a self-adhering peel and stick.
