COMMERCIAL WINDSTORM MITIGATION REPORT

Sunshine Terrace Condominium

COMMERCIAL WINDSTORM MITIGATION REPORT (OIR-B1-1802)

1239 S. Martin Luther King Jr. Ave., Building A

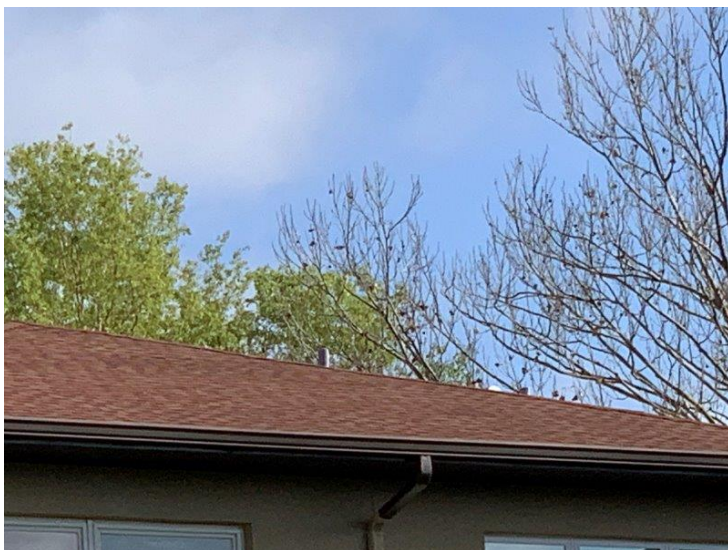
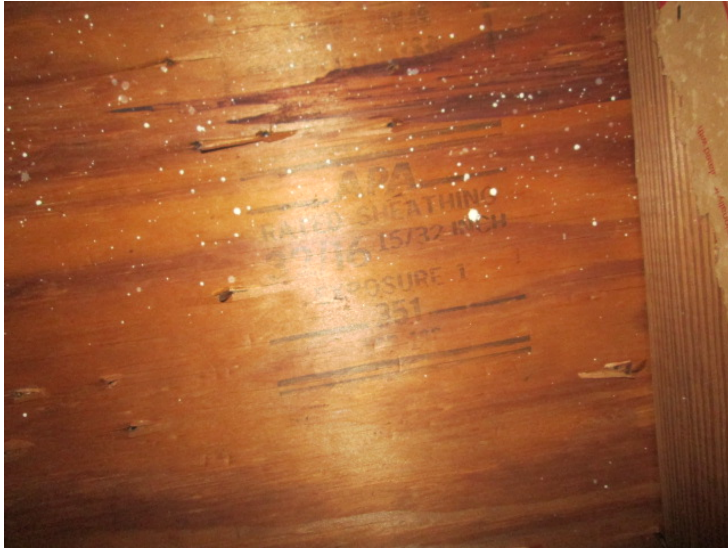
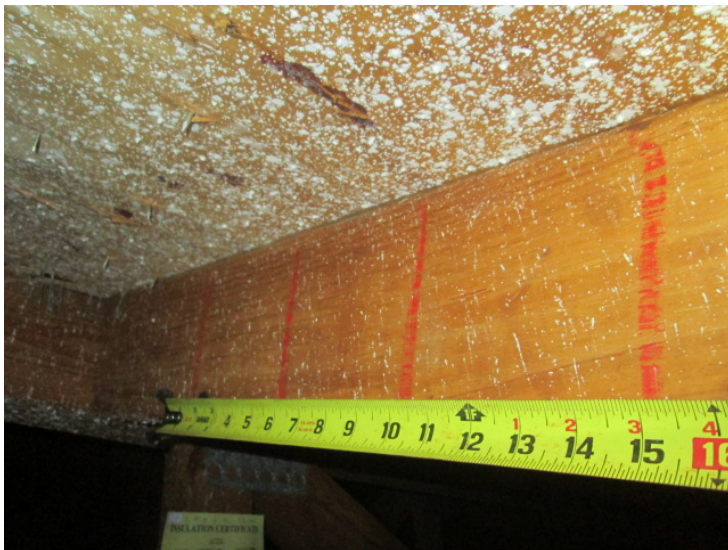
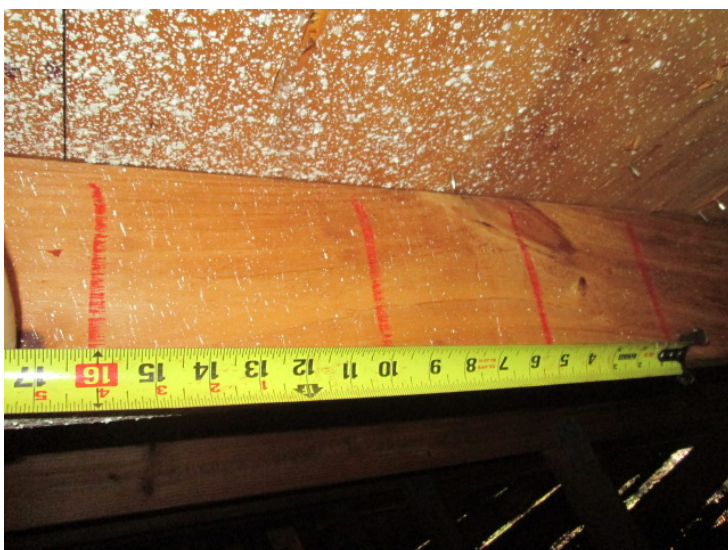
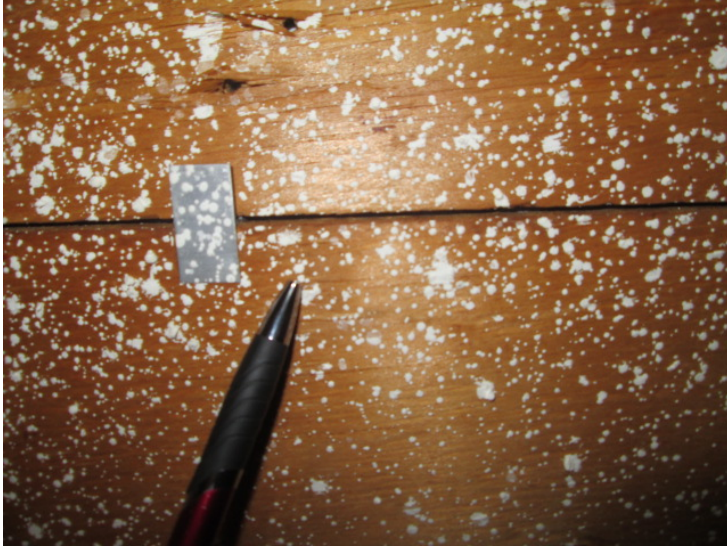
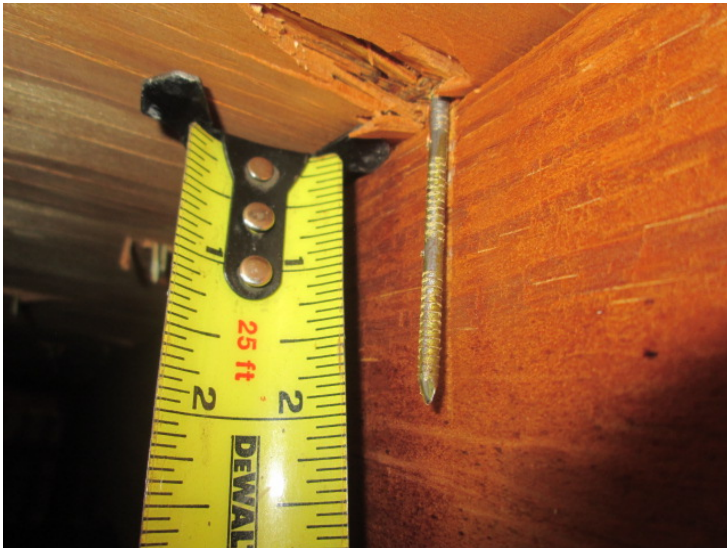
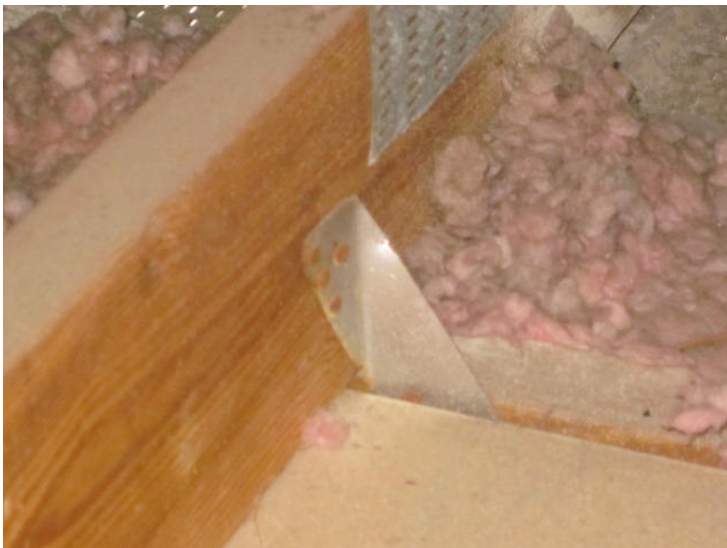
Roof Construction

3. **Roof Deck Attachment:** **Level C**
Comments: Inspection verified 1/2" plywood roof deck attached with 8d nails at a minimum 6" on the edge & 6" in the field.

4. **Roof to Wall Attachment:** **Clips**
Comments: Inspection verified hurricane clips fastened with a minimum of three nails.
5. **Roof Geometry:** **Hip Roof**
Comments: Inspection verified a hip roof shape.

6. **SWR:** **Yes**
Comments: SWR was verified at time of inspection. The Secondary Water Resistance verified is a self-adhering peel and stick.
7. **Opening Protection:** **None or Some Glazed Openings**
Comments: No opening protection verified at the time of inspection.

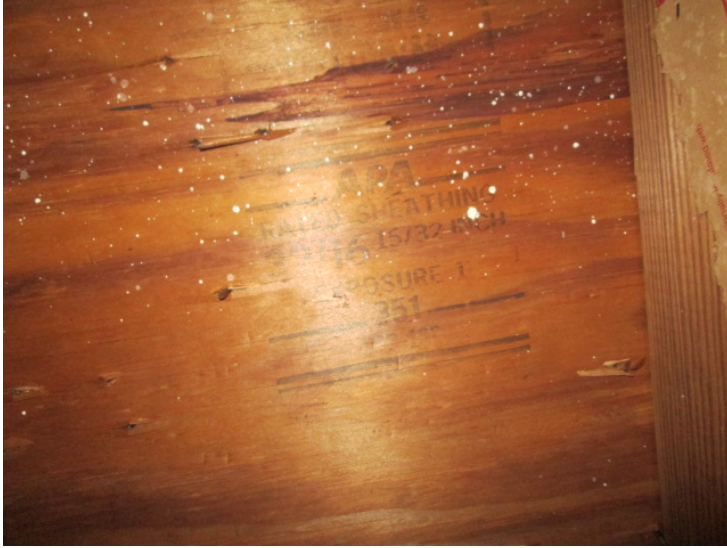
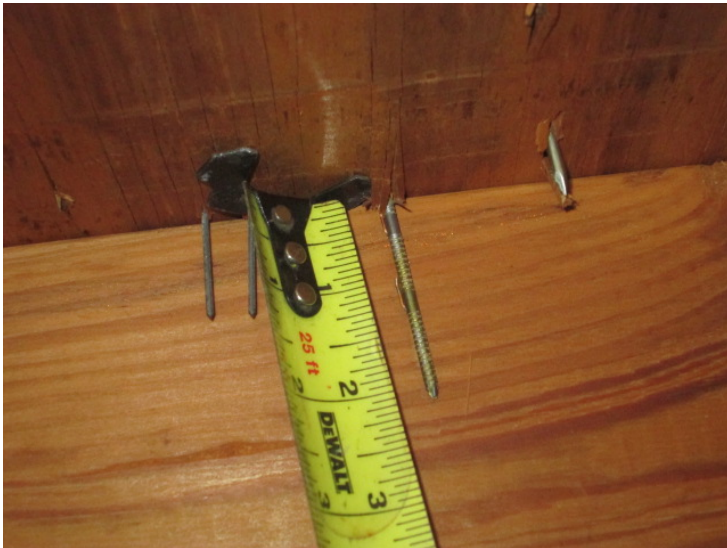
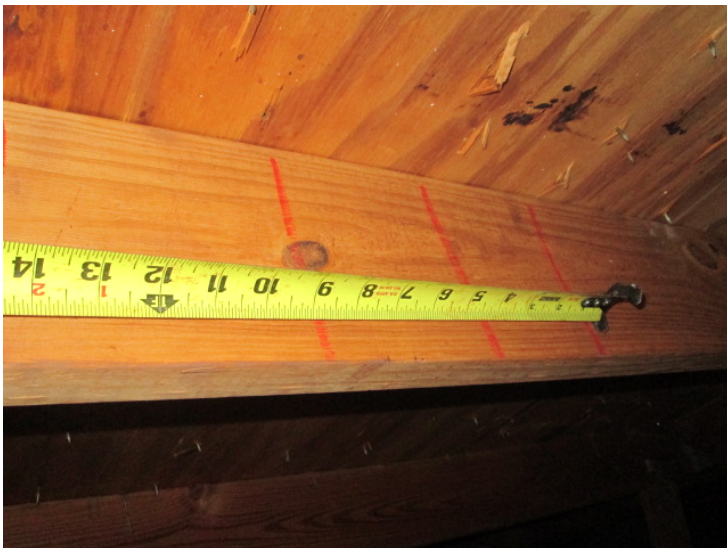
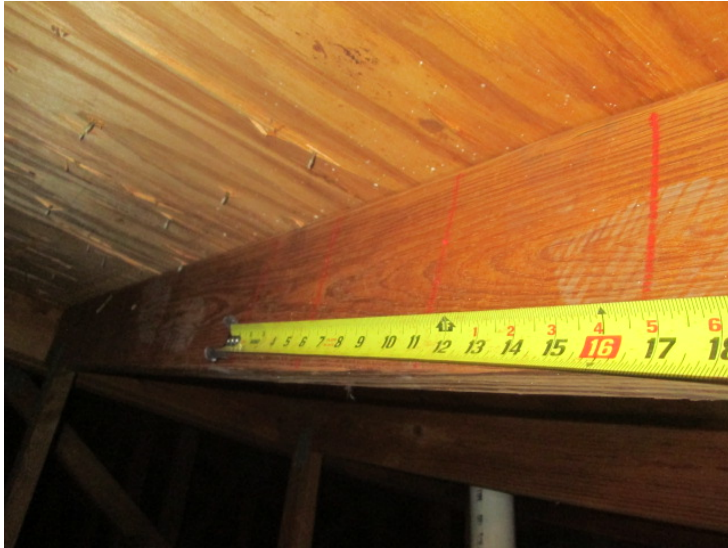
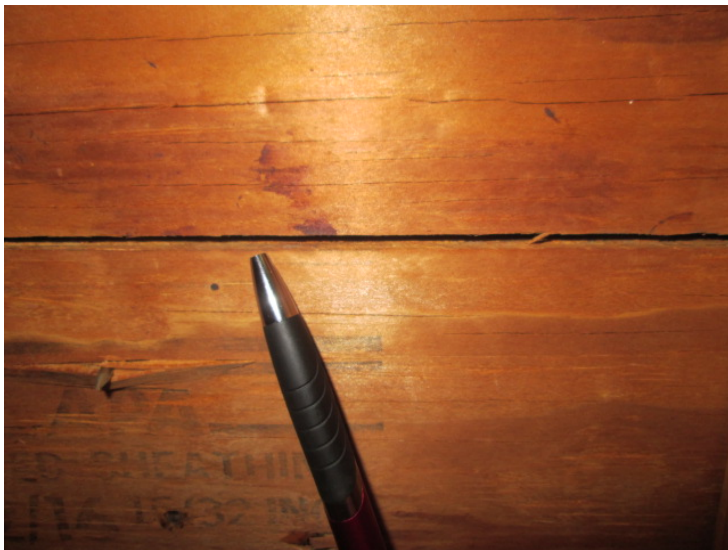
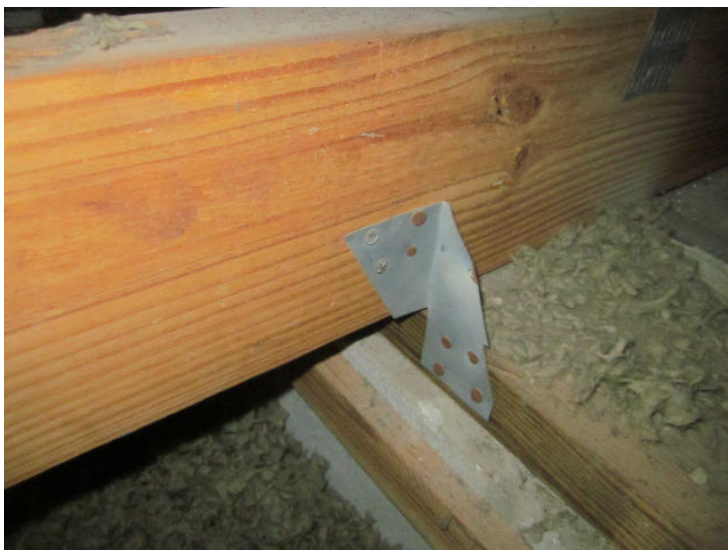
Roof Construction

- 6. SWR:** **Yes**
Comments: SWR was verified at time of inspection. The Secondary Water Resistance verified is a self-adhering peel and stick.
- 7. Opening Protection:** **None or Some Glazed Openings**
Comments: No opening protection verified at the time of inspection.

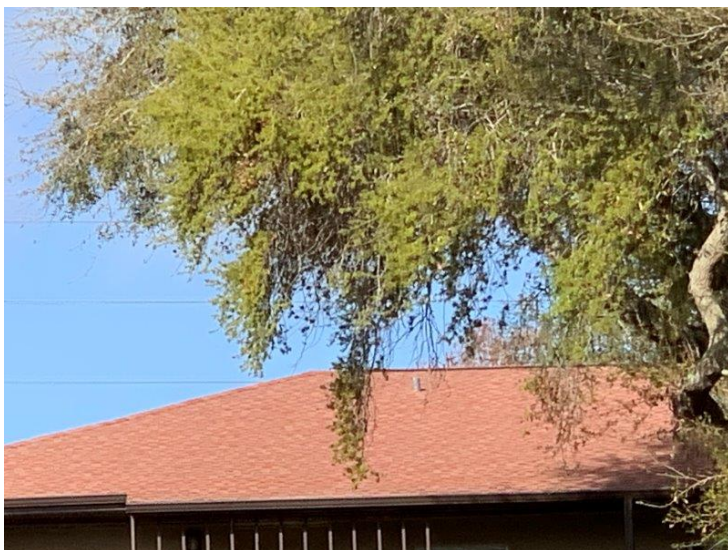
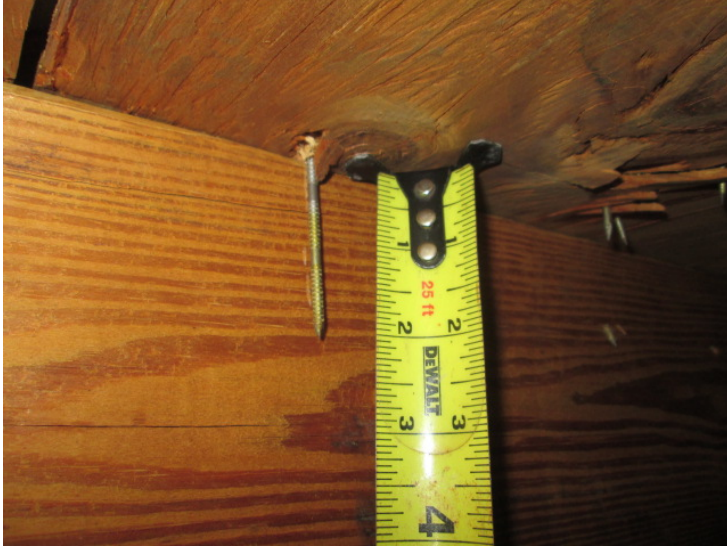
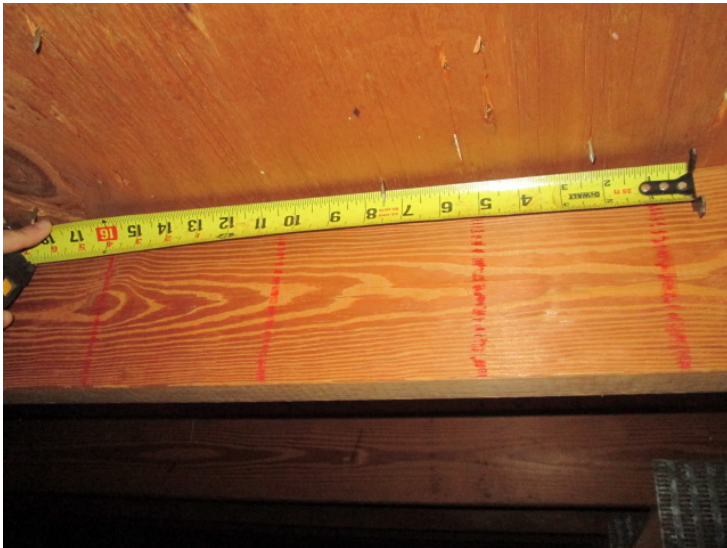
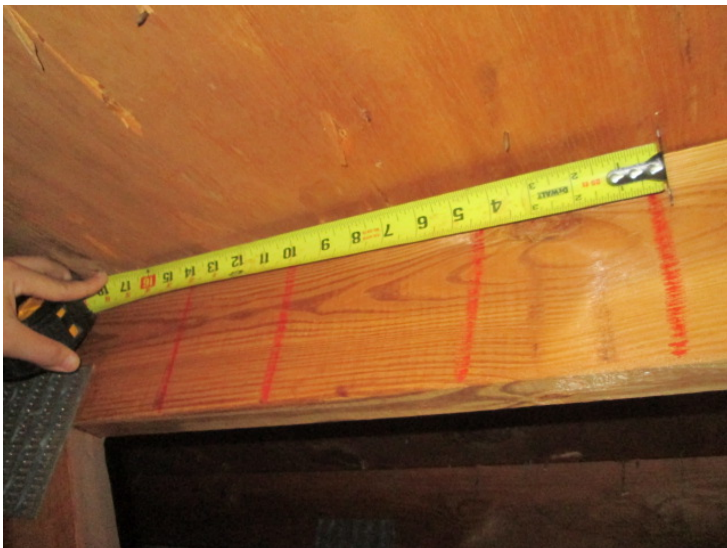
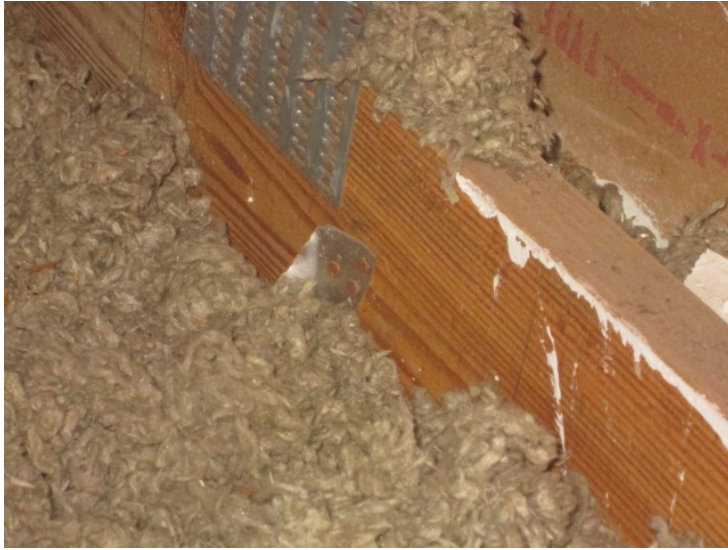
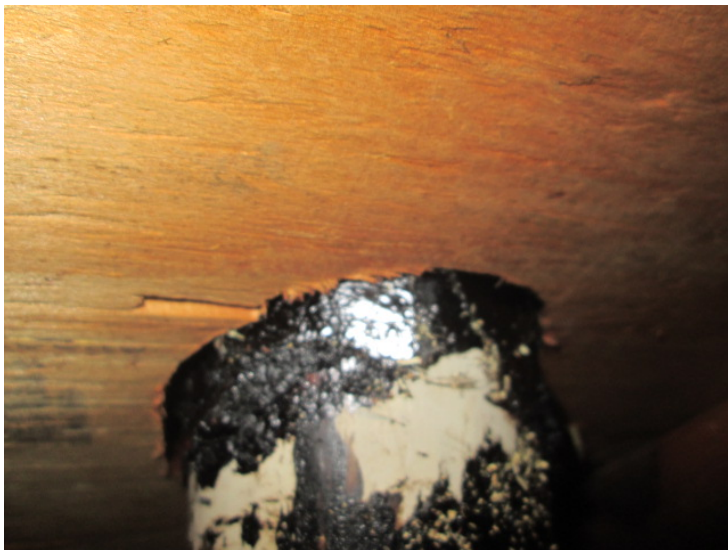
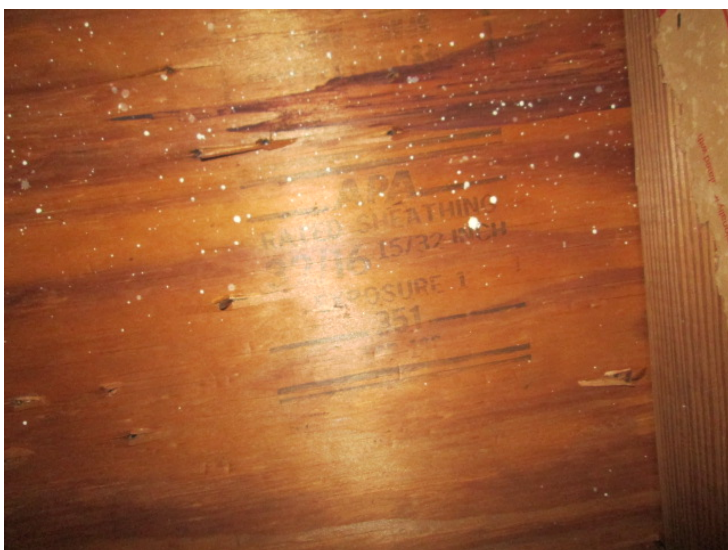
Roof Construction

- 4. Roof to Wall Attachment:** **Clips**
Comments: Inspection verified hurricane clips fastened with a minimum of three nails.
- 5. Roof Geometry:** **Hip Roof**
Comments: Inspection verified a hip roof shape.

- 6. SWR:** **Yes**
Comments: SWR was verified at time of inspection. The Secondary Water Resistance verified is a self-adhering peel and stick.
- 7. Opening Protection:** **None or Some Glazed Openings**
Comments: No opening protection verified at the time of inspection.
